DOT/FAA/AR-99/6

Fiber-Reinforced Structures for Turbine Engine Rotor Fragment Containment

September 1999

Final Report

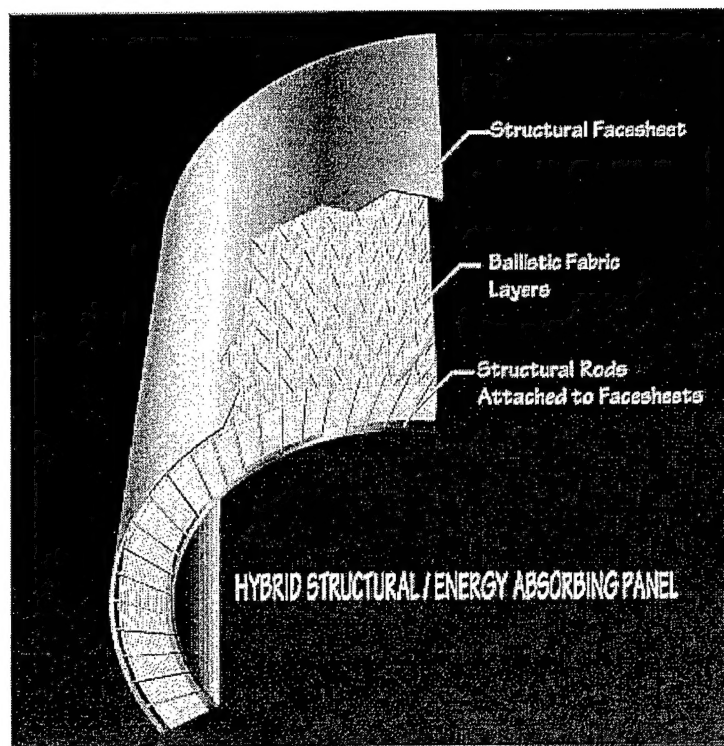
FIGURE 1. HYBRID STRUCTURAL/ENERGY-ABSORBING PANEL

This program was built upon previous work [1] to develop lightweight fiber-reinforced structures to contain turbine engine rotor failures. In this previous program a hybrid sandwich panel concept was shown to be effective as both a static structure member and as a containment barrier to protect critical aircraft systems from high-energy fragments. This concept is a sandwich panel whose core consists of dry, energy-absorbing fabric layers. This dry laminate is penetrated through its thickness by many closely spaced rigid rods which are attached to the panel's facesheets. These rods mechanically connect the facesheets as would a honeycomb core such that the panel can support shear, compressive, and tensile loads. Figure 1 shows a drawing of this panel.

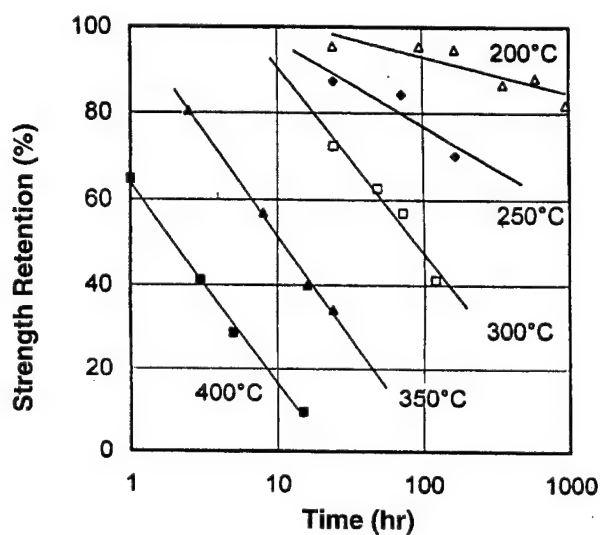
FIGURE 2. TENSILE STRENGTH RETENTION AFTER THERMAL TREATMENT IN AIR OF THE PBO FIBER

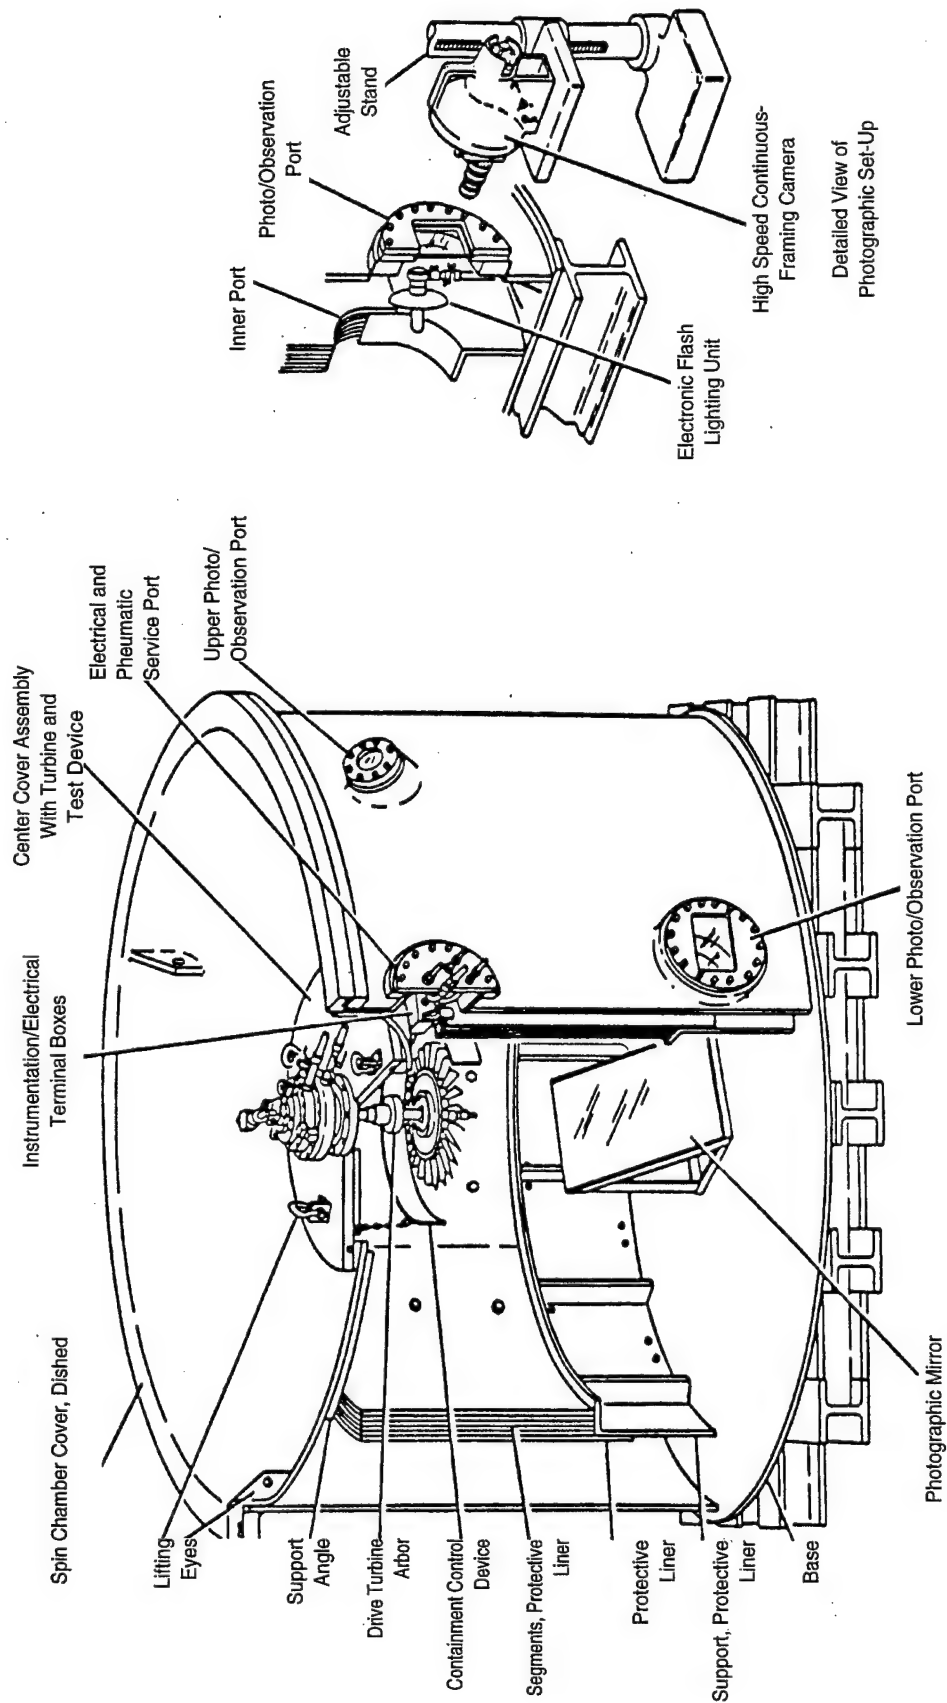
FIGURE 3. ROTOR SPIN FACILITY AT THE NAVAL AIR WARFARE CENTER-AIRCRAFT DIVISION

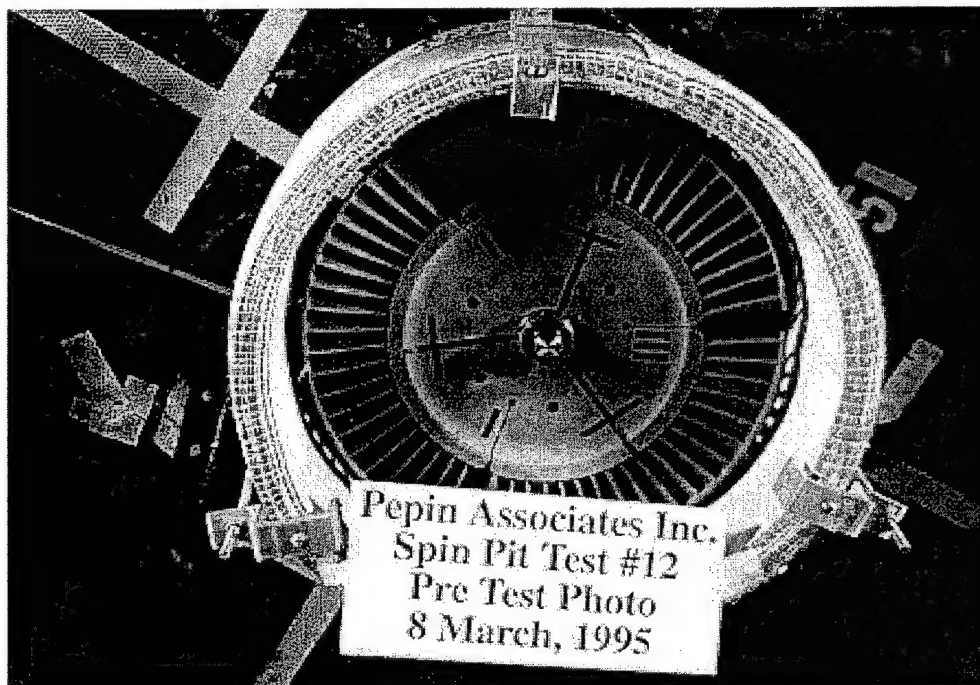
FIGURE 4. BASELINE S GLASS RING MADE OF A [0/90] S GLASS FABRIC WRAP WITH TEFLON INTERLEAVES

The baseline S glass containment ring was fabricated by wrapping a dry fabric around a 37.18-cm-diameter mandrel to form a multi-ply ring. The fabric was a [0/90] plain weave using 1250 yield S glass from Owens Corning. The fabric weave spacing was 9.4 x 9.4 cm and the fabric was wrapped such that the fiber reinforcement directions of the fabric were aligned with the axial and circumferential directions of the ring. Each ply of the fabric was interleaved with a 0.025-mm-thick Teflon film to reduce abrasion between plies of the glass during the impact. The total number of plies was 38.5 and the ring had a mass of 9.64 kg (21.25 lbs). The ring axial length was 25 cm and this dimension is common to all the test rings. The top and bottom edges of the ring were sewn with Kevlar thread to increase the ring's rigidity. Figure 4 shows this completed ring surrounding the T-53 rotor.

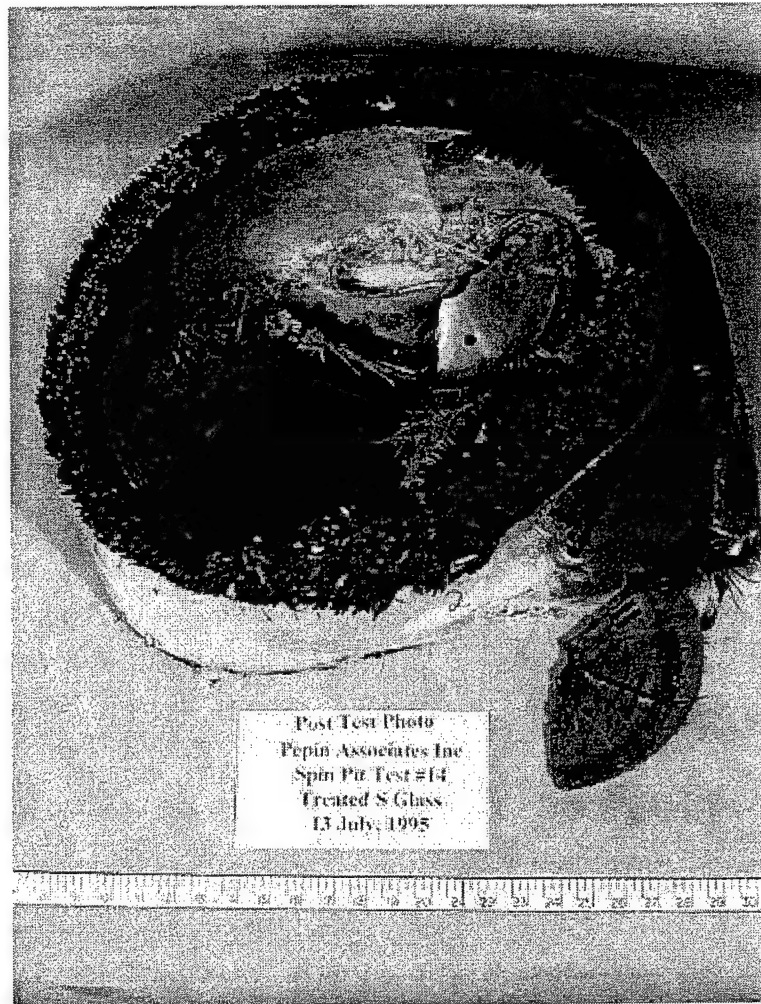
FIGURE 5. POSTTEST PHOTO OF THE COATED S GLASS RING

The test was successfully run. Two disk fragments were contained within the ring while one penetrated through the ring. Blade fragments also escaped through the hole made by the disk fragment. One hole in the witness ring, about 10.16 cm long, was probably the result of a broken air-drive turbine shaft fragment upon failure. Figure 5 is a posttest photo of this ring showing the hole made by the disk fragment which escaped.

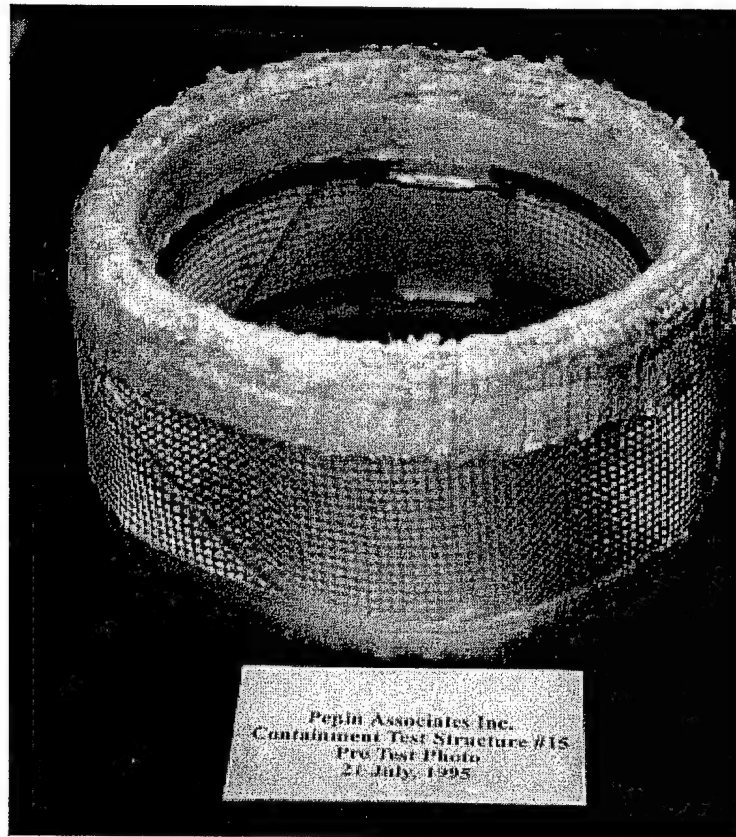
FIGURE 6. S GLASS RING WITH $\pm 45^\circ$ REINFORCEMENT

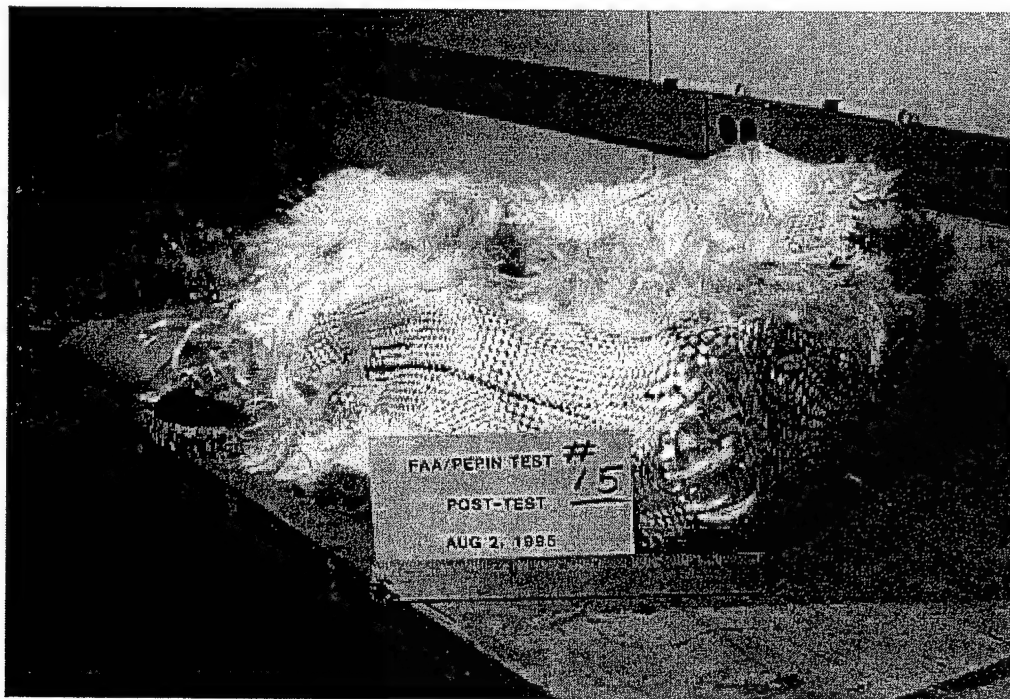
FIGURE 7. POSTTEST PHOTO OF S GLASS RING WITH $\pm 45^\circ$ REINFORCEMENT

The S Glass ring with $\pm 45^\circ$ reinforcement did not contain the rotor burst. One of the disk fragments penetrated the ring wall while the other two remained within the ring. Figure 7 is a posttest photo of this ring.

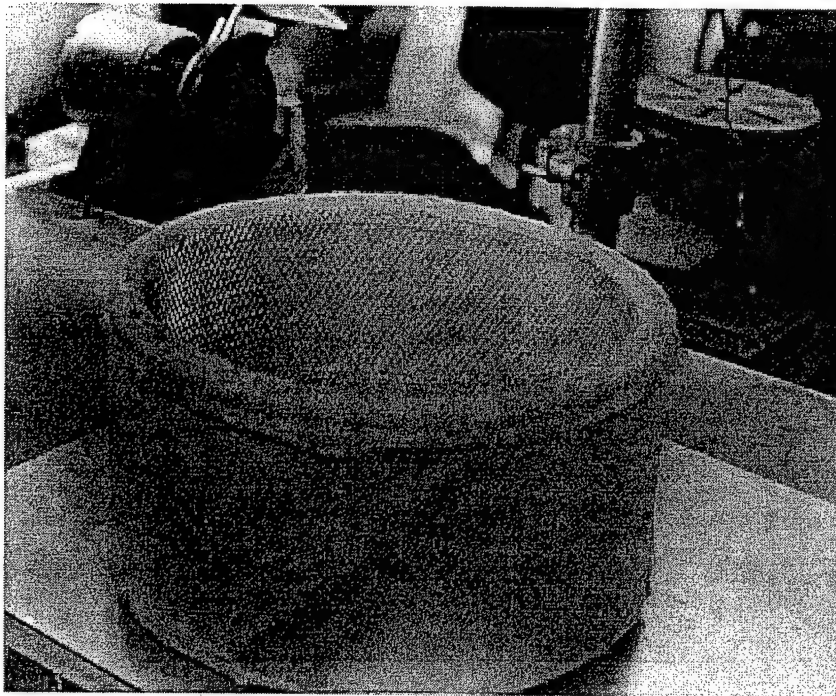
FIGURE 8. LAYUP OF BASELINE KEVLAR RING WHICH FORMS THE ENERGY-
ABSORBING CORE OF THE HYBRID SANDWICH PANEL DESIGN

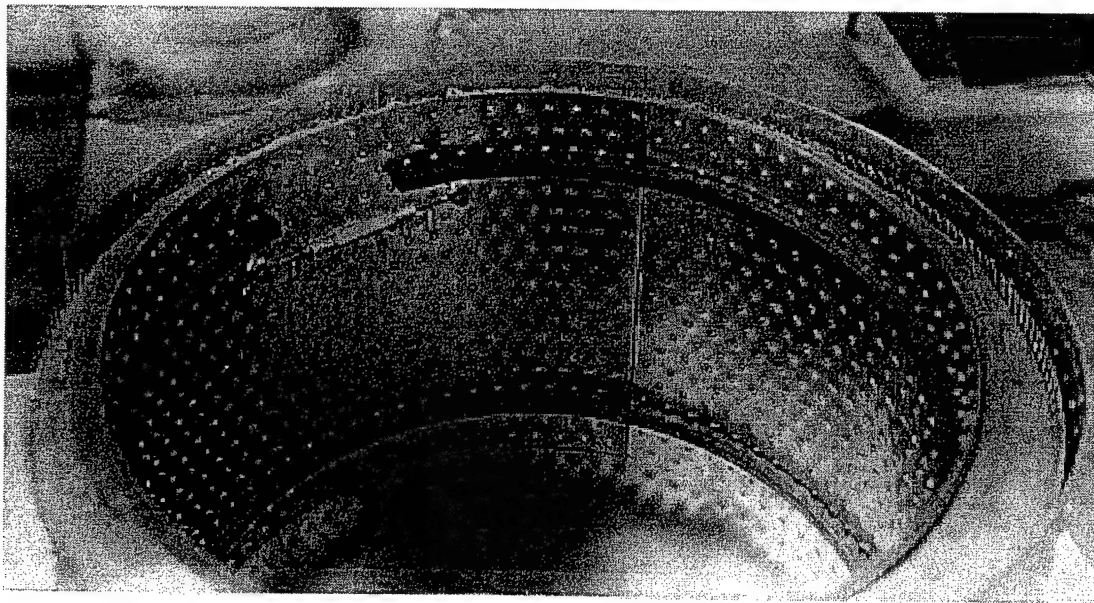
FIGURE 9. PREPUNCHED FACESHEETS PLACED AROUND THE
OD AND ID SURFACES

After the Kevlar layup had been fabricated and sewn into the ring shape, 5052 aluminum facesheets 0.812 mm thick with prepunched holes were wrapped around the inside and outside diameters of the ring and held in place with tie wraps at the outer diameter (OD) and steel rings at the ID. Aluminum rods, 1.57 mm in diameter, were then inserted manually through holes in the facesheets. These rods were also 5052 aluminum and were inserted at $+45^\circ$ and -45° to the facesheets alternating between one circumferential row and the next. The rods were then cut to allow them to just protrude above the facesheets, and these joints were then tungsten-inert-gas (TIG) welded. Aluminum endcap sheets were then welded into place to cover the ends of the ring. The total mass of the ring was 7.14 kg while the mass of the Kevlar alone was 5.39 kg. Figures 8 through 10 show the sequence of manufacturing steps. The finished ring is shown in figure 11. Figure 12 shows a drawing of the ring and figure 13 shows the ring installed in the spin chamber.

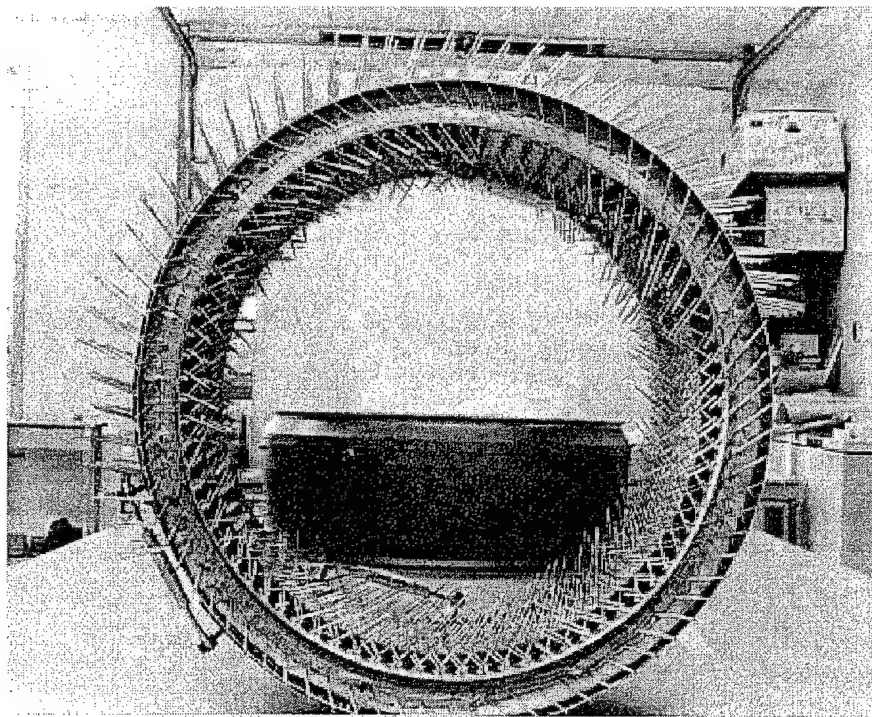
FIGURE 10. RING SHOWN AFTER RODS HAVE BEEN INSERTED THROUGH THE
FACESHEETS AND CORE

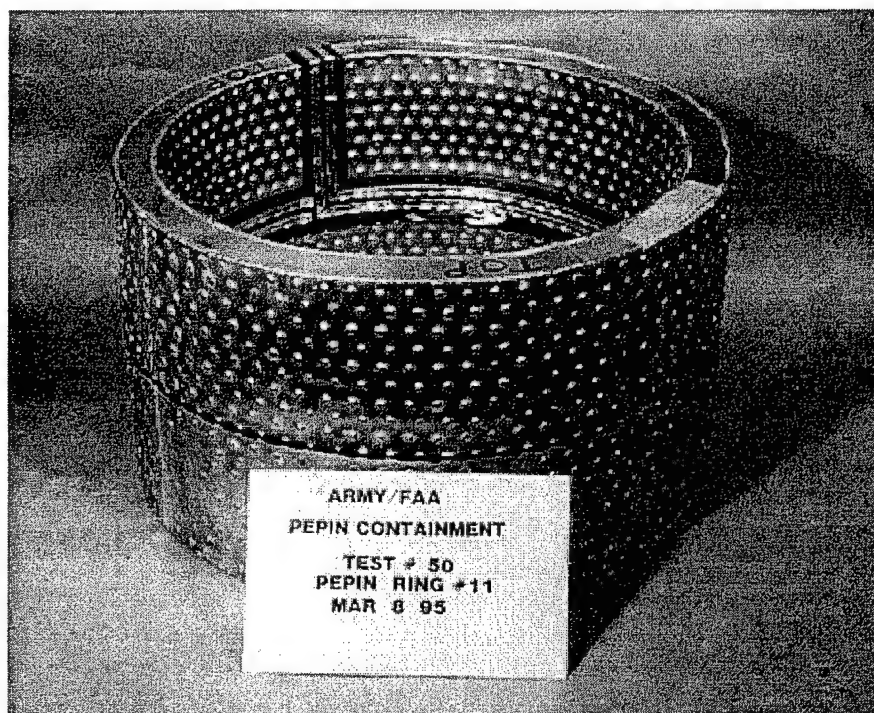
FIGURE 11. BASELINE KEVLAR CORE RING WITH ALUMINUM STRUCTURE
COMPLETE AND READY FOR TESTING

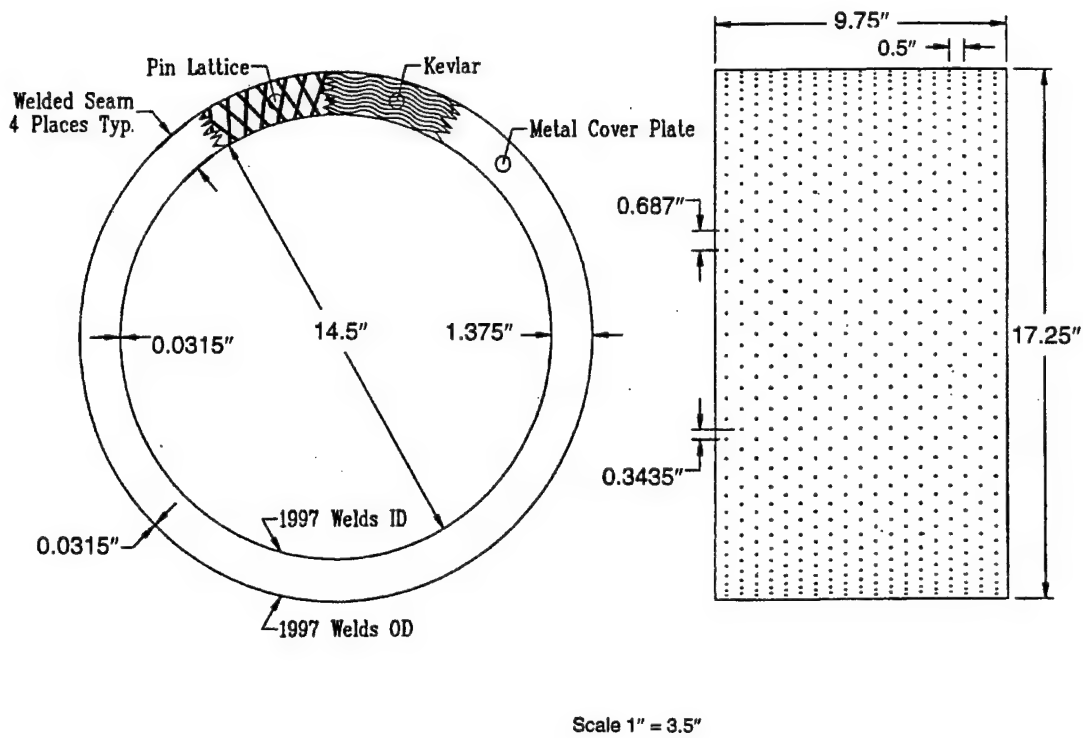
FIGURE 12. DRAWING OF BASELINE SMALL-DIAMETER KEVLAR RING SHOWING DIMENSIONS

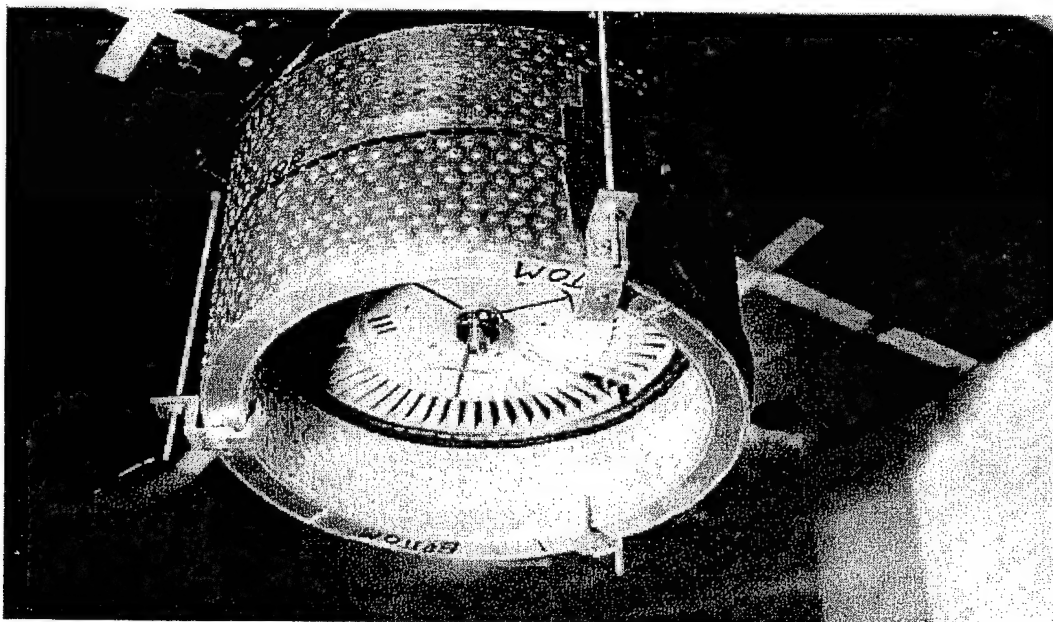
FIGURE 13. BASELINE KEVLAR CORE RING INSTALLED IN THE SPIN CHAMBER

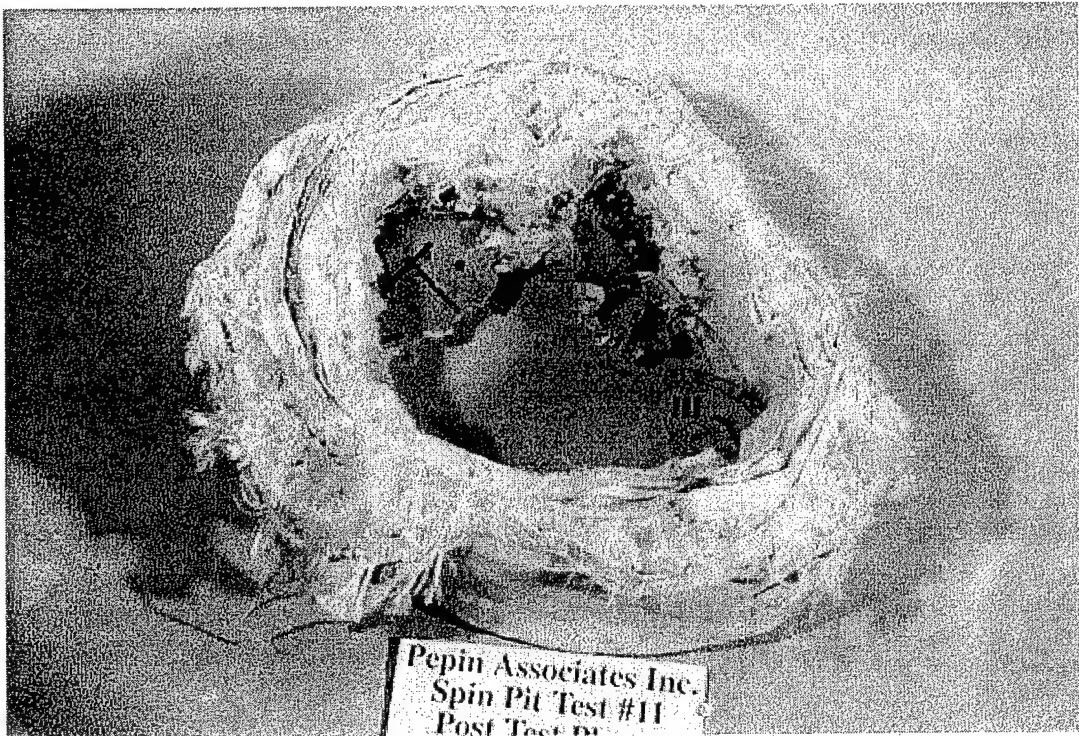
FIGURE 14. POSTTEST PHOTO OF BASELINE KEVLAR-CORED HYBRID RING

The T-53 rotor failed at 20,800 rpm, but one of the disk fragments broke up into several smaller pieces. Even though all of the fragments were contained, the test was invalid because of the breakup of one of the disk segments. The trihub burst is the most severe containment condition and the one to which all of the other containment structures are compared. This test therefore had to be repeated. A posttest photo is shown in figure 14. The high-speed photos of figure 15 depict the event at the various time steps shown. Note the breakup of one of the disk fragments and the deformation of the containment ring as the disk fragments impact.

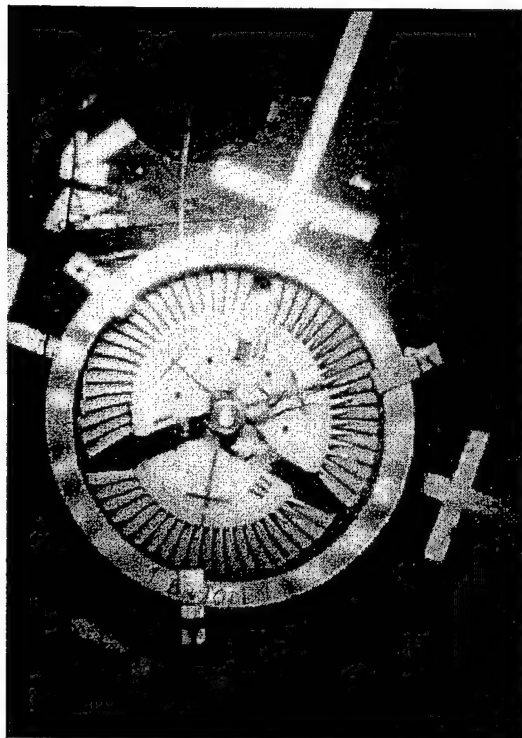
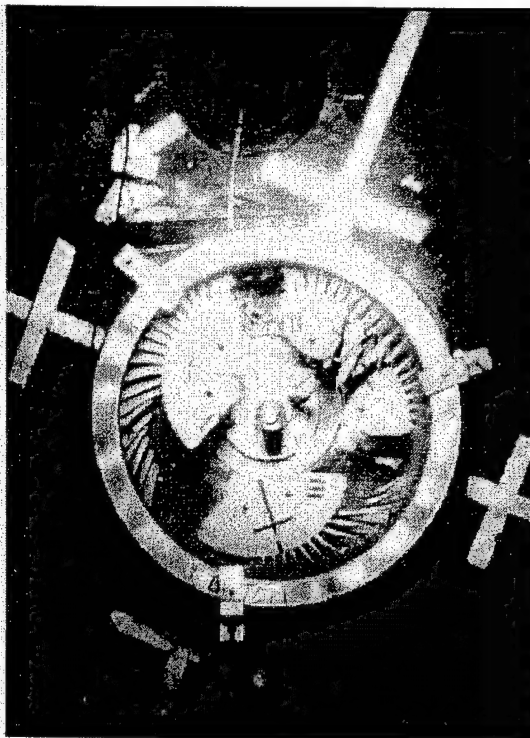
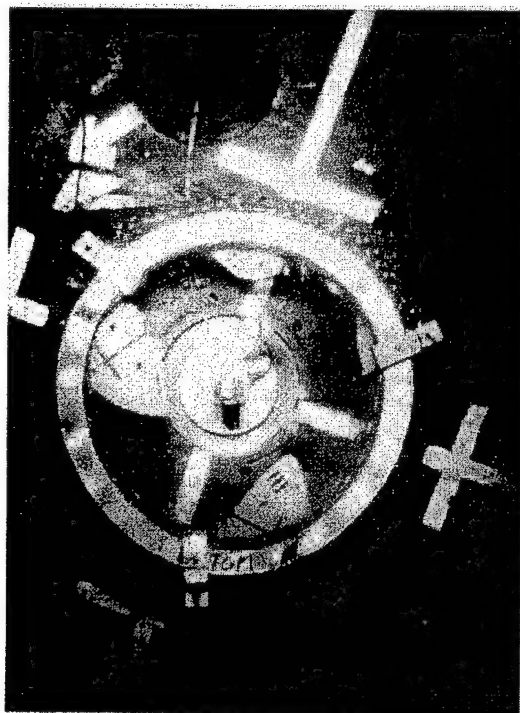
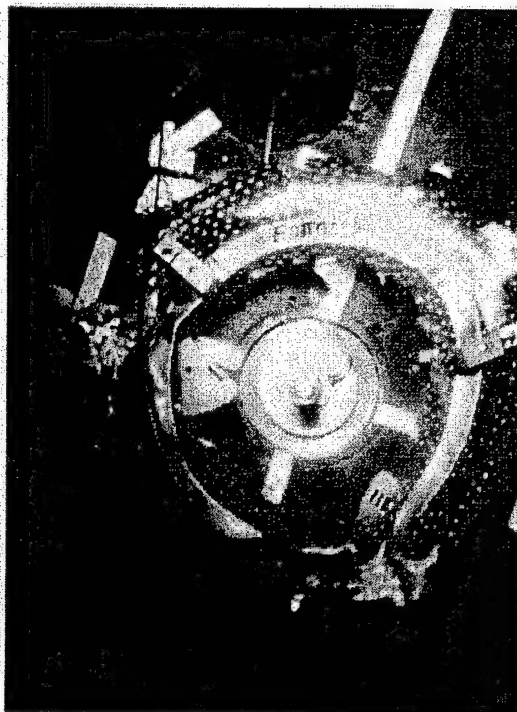
FIGURE 15. HIGH-SPEED PHOTOS OF THE BASELINE KEVLAR-CORED ALUMINUM HYBRID RING DURING TEST

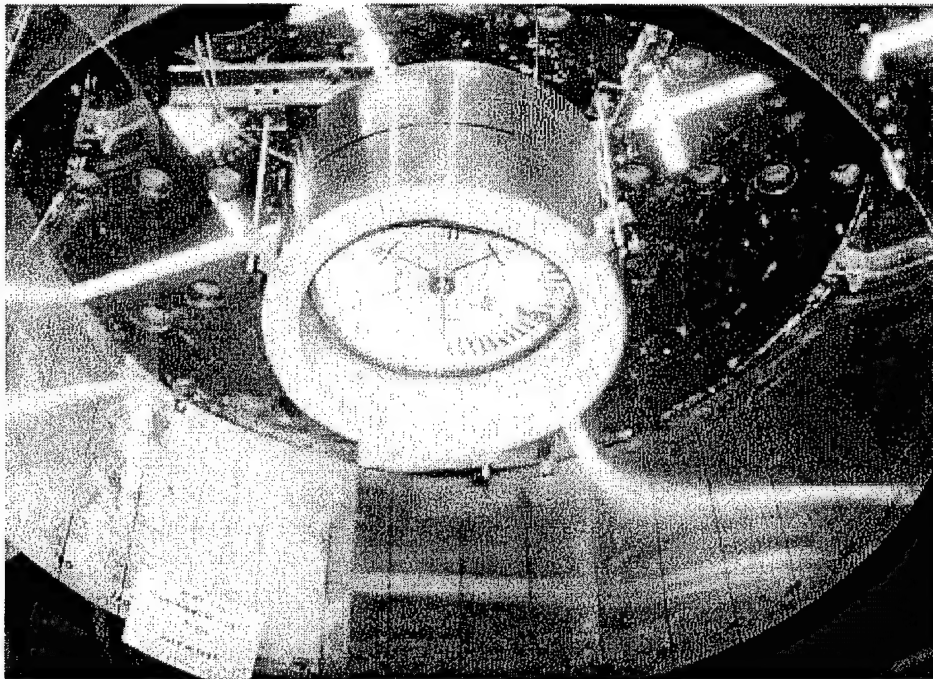
FIGURE 16. SECOND BASELINE KEVLAR/ALUMINUM HYBRID RING MOUNTED IN THE SPIN TEST CHAMBER

Aluminum facesheets were then wrapped to touch the exposed rod ends on both the ID and OD surfaces. These facesheets were held in place by injecting urethane foam in the annular region between the facesheet surface and the fabric surface. The foam flowed around the exposed rods and, upon curing, bonded the facesheets to the ring. This was not a structural bond but merely demonstrated a concept for possible future attachment of the facesheets with a stronger foam or other injectable material. This method of facesheet attachment would not materially affect the test outcome since the containment ability of the ring is dominated by the ballistic fabric core design. This second baseline ring is shown suspended from the cover in the spin chamber in figure 16. The mass of this ring was 8.81 kg and the mass of the Kevlar core was 6.84 kg.

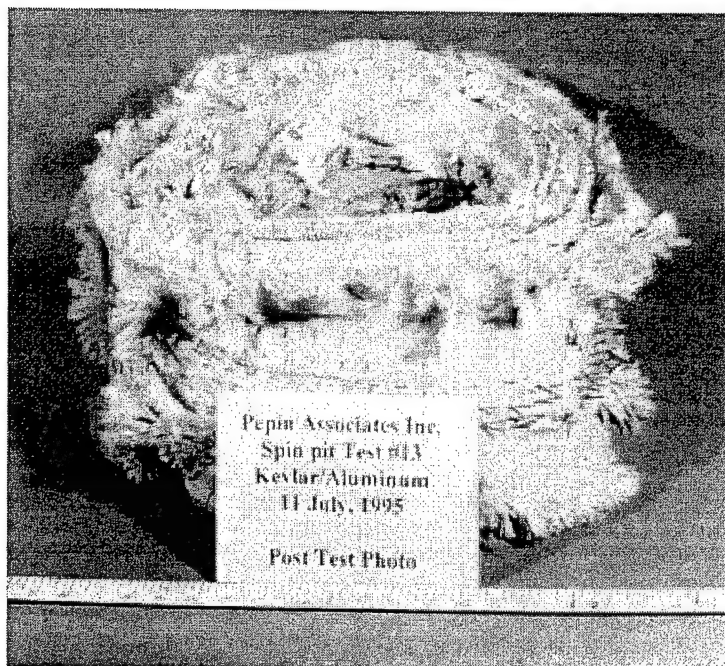
FIGURE 17. POSTTEST PHOTO OF SECOND BASELINE KEVLAR/ALUMINUM HYBRID RING

This second baseline ring contained all fragments released from the rotor. The three disk fragments were found in the ring itself following the test. All the rods remained in the fabric laminate and the ring height decreased 3 cm as a result of the ring's radial expansion. Figure 17 shows the posttest photo of the ring.

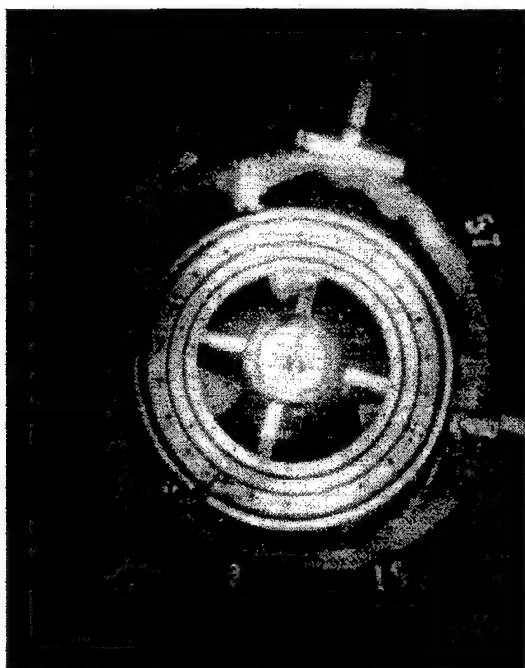
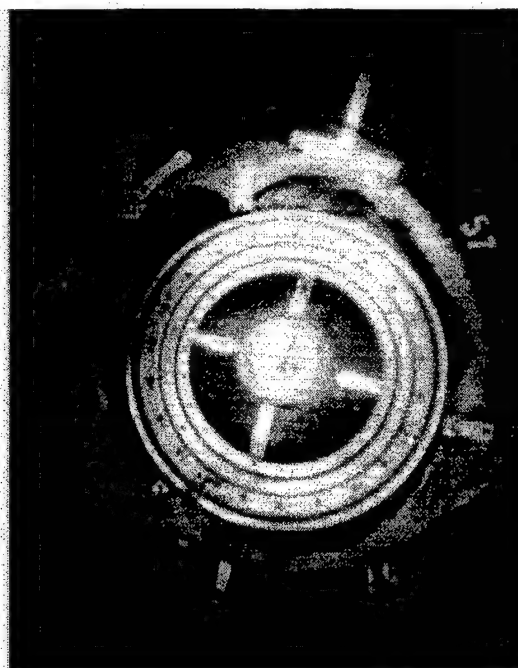
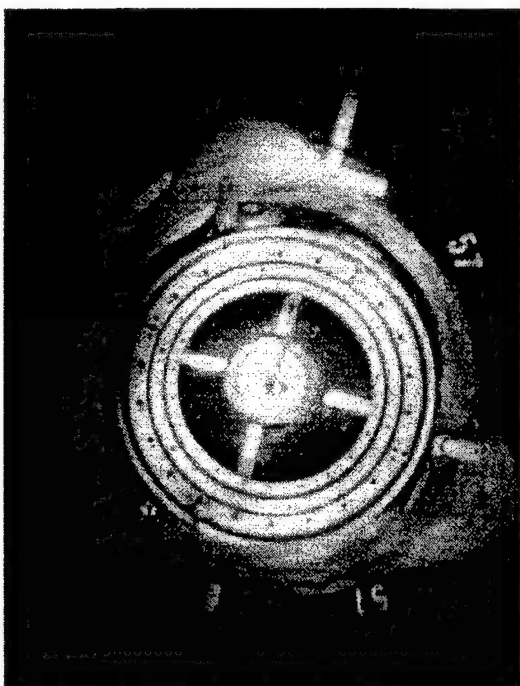
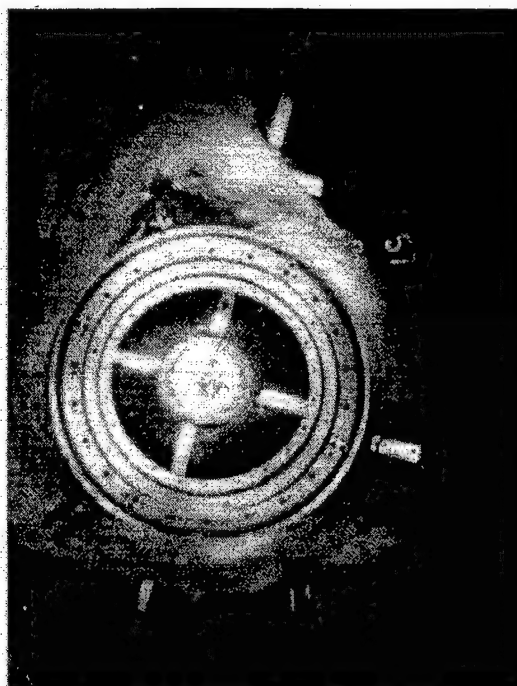
FIGURE 18. HIGH-SPEED PHOTOS OF FIRST LARGE-DIAMETER KEVLAR
CONTAINMENT RING SPIN TEST WITH COMBUSTOR
CASE OF T-53 INSTALLED IN CHAMBER

This ring was tested with the engine combustor case suspended in the spin test chamber. The containment ring completely contained the rotor burst with no penetrations of the witness ring. The trigger strip for the high-speed flash lamps was located on the containment ring ID so the first photo shows the disk fragments partially penetrated into the engine combustor case. Figure 18 shows the high-speed sequence of photographs as the disk fragments impacted the containment ring. The three disk fragments were trapped between the outer case skin and the containment ring. Figure 19 shows a close-up photo of this area.

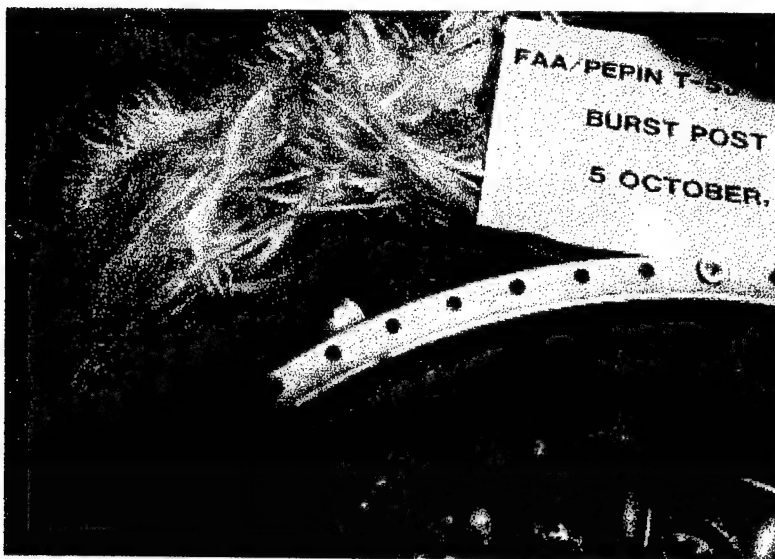
FIGURE 19. CLOSE-UP PHOTO OF AREA BETWEEN COMBUSTOR CASE AND CONTAINMENT RING AFTER TEST OF FIRST LARGE-DIAMETER KEVLAR CONTAINMENT RING

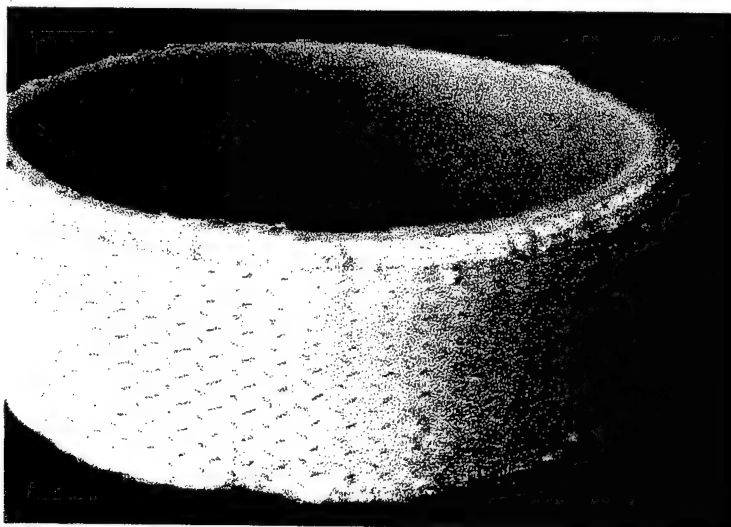
FIGURE 20. THIRTY-PLY KEVLAR CONTAINMENT RING WITH ALUMINUM RODS

The second large-diameter Kevlar containment ring was the same design as the first but with 30 plies instead of 36. Reducing the number of plies would help pinpoint the design threshold to just contain the trihub burst. The 5-cm-wide [0/90] strips were added at the edges of plies 7, 13, 19, and 25 counting from the outside diameter inward. This 30-ply ring had a mass of 7.73 kg. It also had the aluminum rod array inserted through it but no facesheets were attached. A photo of this ring is shown in figure 20. The pink foam is used as backing on the ID during manufacture. The aluminum rods were inserted from the outside surface inward through the fabric and into the foam which was initially wrapped around the internal mandrel.

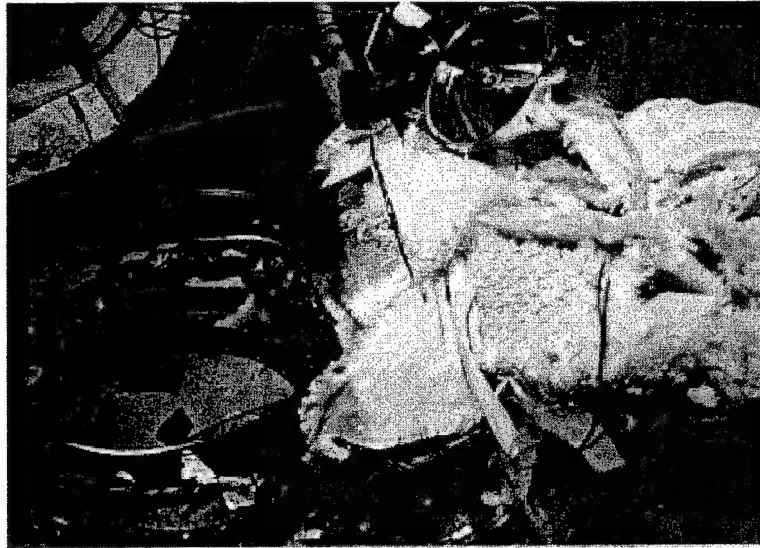
FIGURE 21. THIRTY-PLY KEVLAR CONTAINMENT RING AFTER TEST; CLOSE-UP VIEW IN CHAMBER

The ring was suspended around the engine combustor case as before and the test was performed successfully. The ring contained all three disk fragments. There were two holes in the witness ring similar to those which might be caused by blade fragments. In past tests on previous programs, blades have been driven through the ring wall by a following disk segment but the disk segment itself was usually stopped. Figures 21 through 23 show posttest photos of the ring and combustor case.

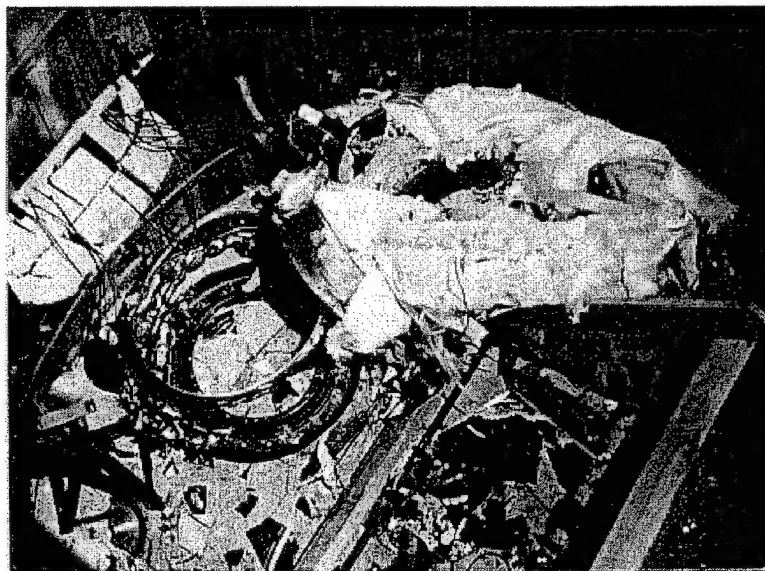
FIGURE 22. THIRTY-PLY KEVLAR CONTAINMENT RING AFTER TEST; DISTANT VIEW IN CHAMBER

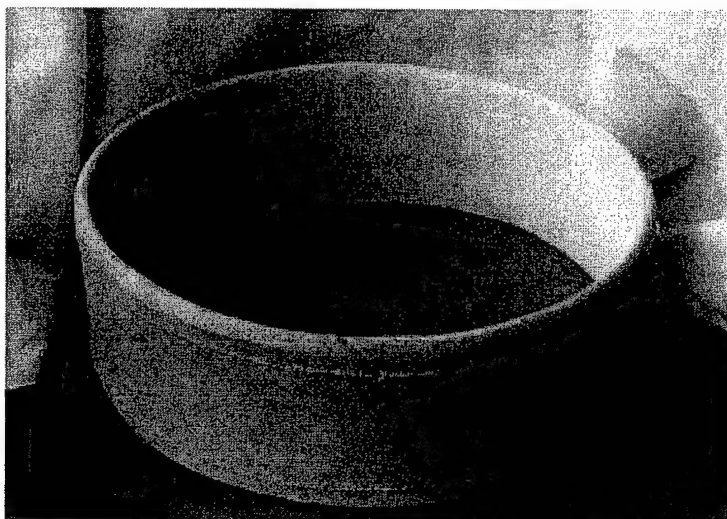
FIGURE 24. PRETEST PHOTO OF THE LARGE-DIAMETER 30-PLY KEVLAR RING TESTED WITHOUT THE ENGINE COMBUSTOR CASE

The test was performed to evaluate the contribution of the engine structure to containment in the previous tests. The ring design was the same as for the previous ring but this time the engine structure was not installed in the spin chamber. From the ID to the OD, this ring contained one $\pm 45^\circ$ ply, (one double ply, five $\pm 45^\circ$ plies) [7], and one $\pm 45^\circ$ ply for a total of thirty plies of the style 745 Kevlar 29 fabric. No aluminum rods were inserted into this ring. The mass of the ring was 7.3 kg (16 lb). Its ID was 67.5 cm and the axial length was the same as for the other rings. Figure 24 shows a photo of this ring before testing.

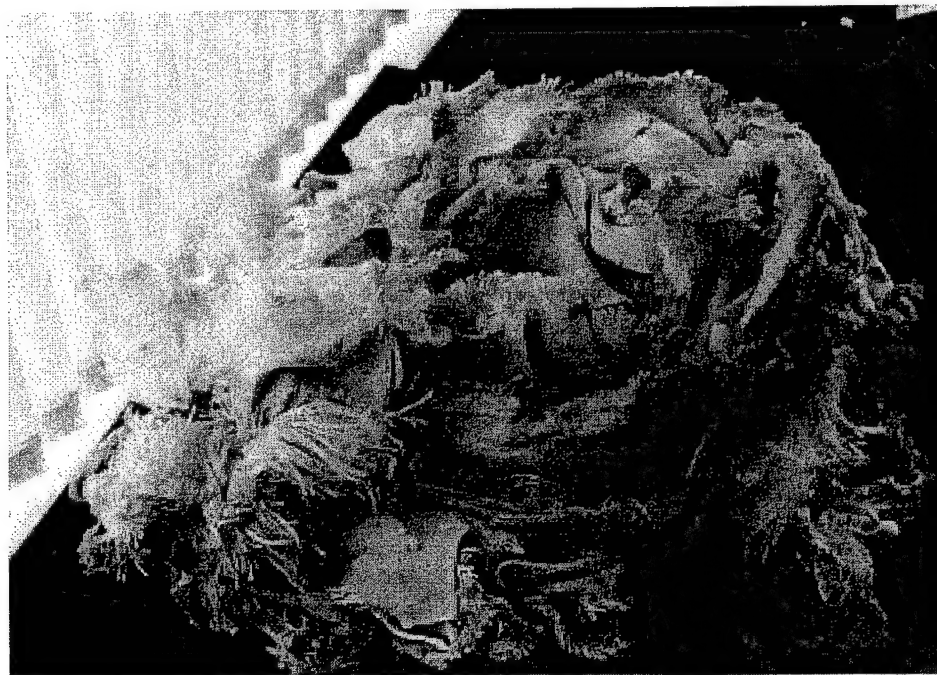
FIGURE 25. POSTTEST PHOTO OF THE LARGE-DIAMETER 30-PLY KEVLAR CONTAINMENT RING TESTED WITHOUT THE ENGINE COMBUSTOR CASE

The large-diameter ring was tested and it successfully contained all three disk fragments. The plies of the ring were significantly separated and unraveled as a result of the impacting fragments. This demonstrates the value of through-the-thickness aluminum rods as the rods tended to hold the plies together. Although a lighter-weight ring was not tested, the ring design tested is probably close to the threshold of containment. If this is so, then the engine structure does not contribute significantly to the disk fragment energy absorption; that is, the disk segments do not lose a significant amount of their energy passing through the engine structure. Figure 25 is a photo of this ring after testing.

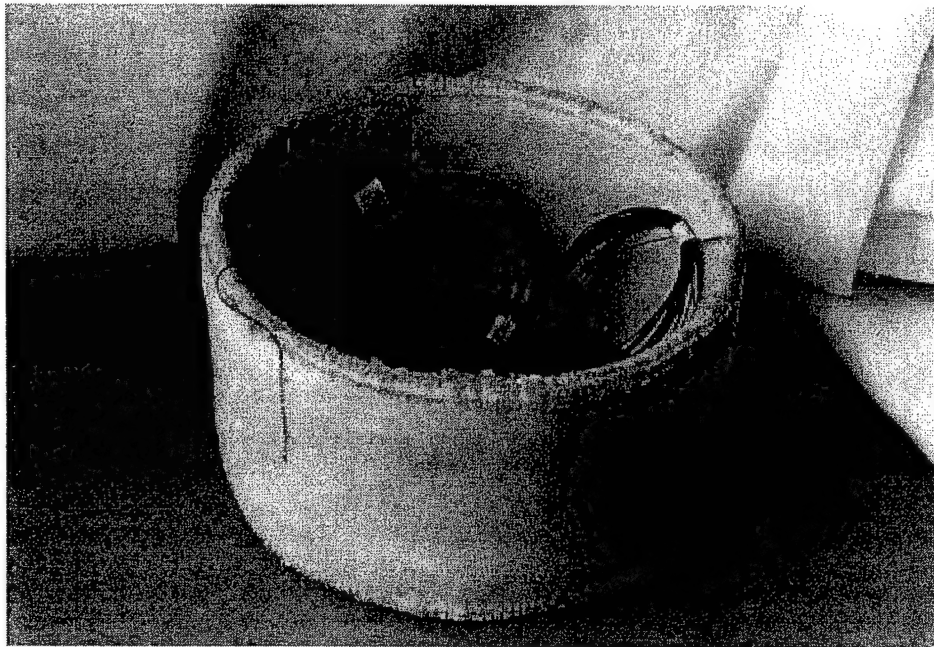
FIGURE 26. KEVLAR THERMAL TEST RING BEFORE TEMPERATURE EXPOSURE

tested, it was heated in an oven to a temperature of 160°C in air for 500 hours. The degradation of Kevlar and similar fibers is a function of the time/temperature history of the fiber in service. Tests have been done at DuPont to identify the strength loss of Kevlar 29 when exposed to a given temperature over a period of time. Table 2 of section 2.1 shows that Kevlar 29 will retain 90% of its tensile strength after being exposed to 160°C air for 500 hours. Figure 26 shows the ring with imbedded thermocouples at the ID and OD. A thermocouple was also imbedded in the middle of the layup.

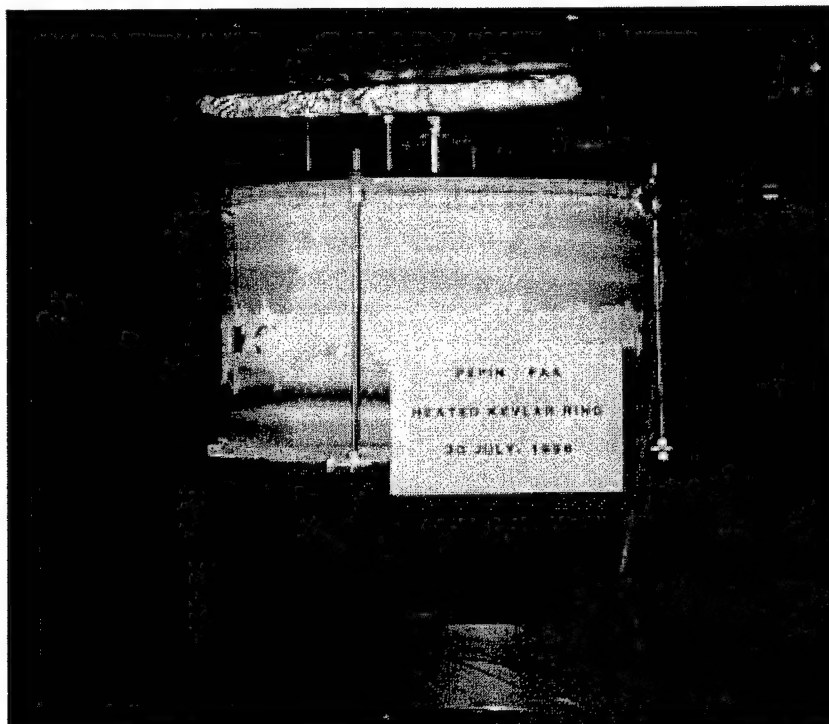
FIGURE 27. KEVLAR THERMAL TEST RING MOUNTED TO CHAMBER COVER
READY FOR TESTING

the ring and acted as a witness shield. Two shallow dents were found in this sheet but no holes were found. Figure 27 shows the ring mounted to the spin chamber cover but the oven has not yet been placed over it. Figure 28 is a posttest photo and figure 29 shows the heating element inside the oven.

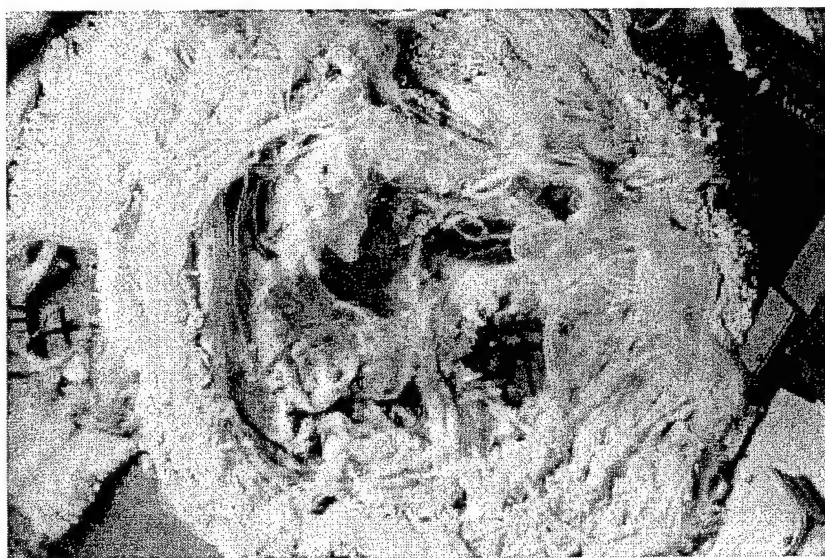
FIGURE 28. POSTTEST PHOTO OF KEVLAR THERMAL TEST RING

The ring was tested and it successfully contained all three disk fragments. One of the fragments opened a hole in the ring approximately 5 cm in length. This fragment did not penetrate through the containment ring thickness. However, after losing most of the kinetic energy upon impact, the fragment dropped on the chamber floor and eventually tumbled outside the containment ring. The two other fragments were found inside the ring. The heat enclosure completely surrounded

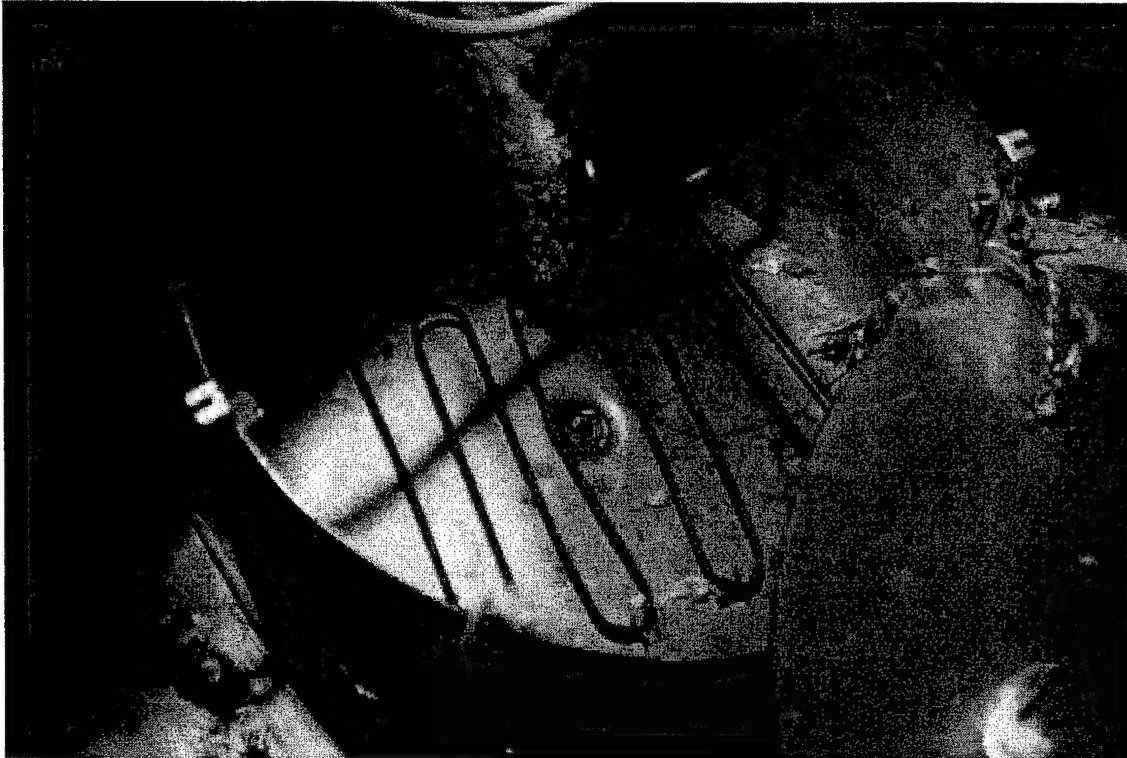
FIGURE 29. OVEN USED TO HEAT THE THERMAL TEST RINGS JUST BEFORE SPIN TESTING
